## Survey Program Technical Memorandum

Wyckoff/Eagle Harbor Superfund Site

*Bainbridge Island, WA*  
September 25, 2017

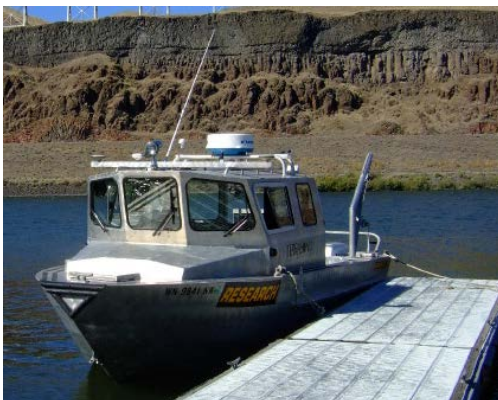
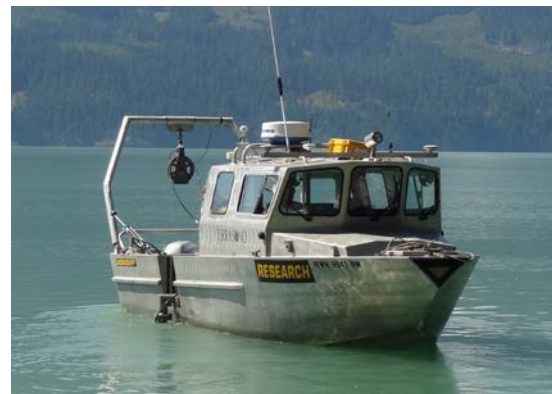
Figure 3 - RV Carta

The vessel used in the survey was the *R/V Carta*, TerraSond's 27-foot, custom built, shallow draft, aluminum survey platform. The vessel is equipped with an over-the-side multibeam pole mount. The mount has a rotary actuator that swings the pole outboard to deploy the sonar. The pole is bolted into place during the survey. The single beam was mounted in the moon pool at mid-ship and slightly to the port side.
